Manhole Inspection Summary

Manhole # S27I__021MH

Inspection ☐ Is Incomplete Rating: **3) Fair**

Location Address: **120 S.Schroeder St.**

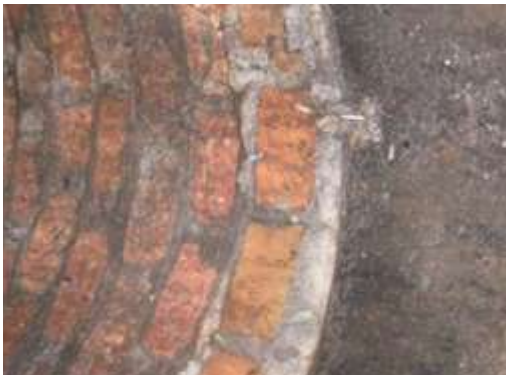
Defect 7

infiltration from under frame

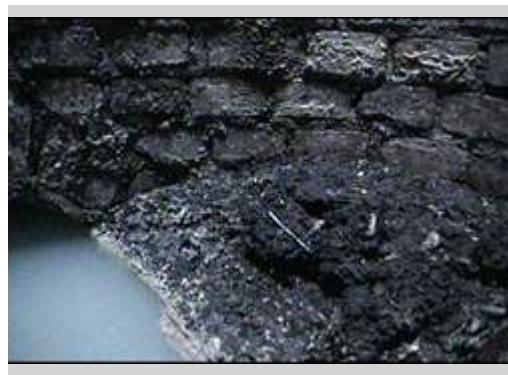
Defect 2

Infiltration: ☐ None ☐ Joint ☐ Cracks ☒ **Mortar** ☐ Roots ☒ **Wall**

Condition: ☐ Sound ☐ Cracked ☐ Root Intrusion ☐ Deteriorated ☐ Leaks ☒ **Debris**

barrel infiltration from mortar & wall,
debris on bench

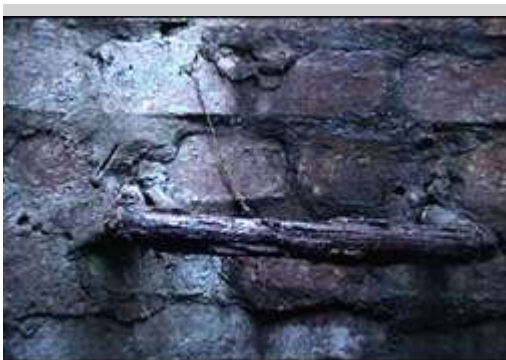
Defect 6

Count: **7** Missing: **0** ☒ **Corroded**

corroded rung

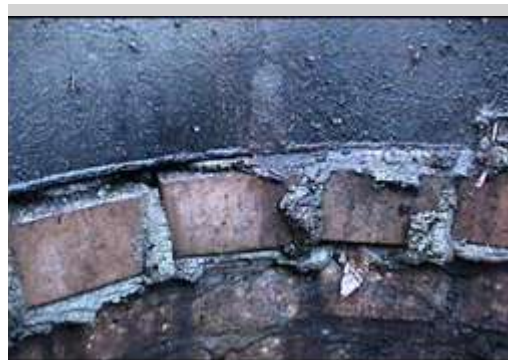
Defect 4

Condition: ☐ Sound ☐ Cracked ☐ Root Intrusion ☒ **Loose Brick** ☒ **Deteriorated**

Infiltration: ☐ None ☒ **Joint** ☐ Cracks ☒ **Mortar** ☐ Roots ☐ Wall

chimney deteriorated & loose bricks with
infiltration from mortar & joint

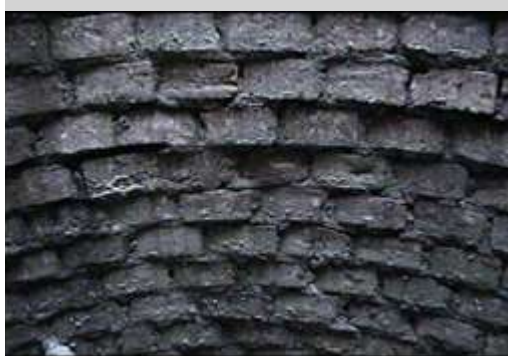
Defect 3

Infiltration: ☐ None ☐ Joint ☐ Cracks ☒ **Mortar** ☐ Roots ☒ **Wall**

signs of corbel infiltration from mortar & walls (mud deposits)

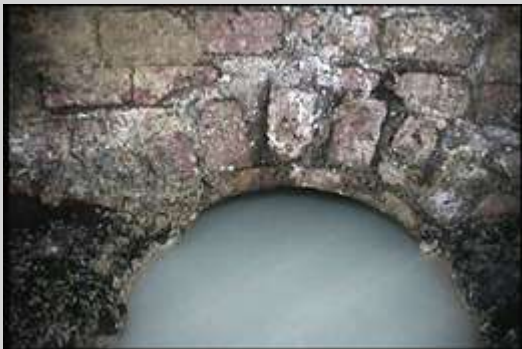
6 O'Clock Inflow

Infiltration: **Evidence** Pipe Seal Cond: **Sound**
